# Aerial roof documentation

## Contractor review sample

Capture date 29 Sep 2026    Location Montauk, New York

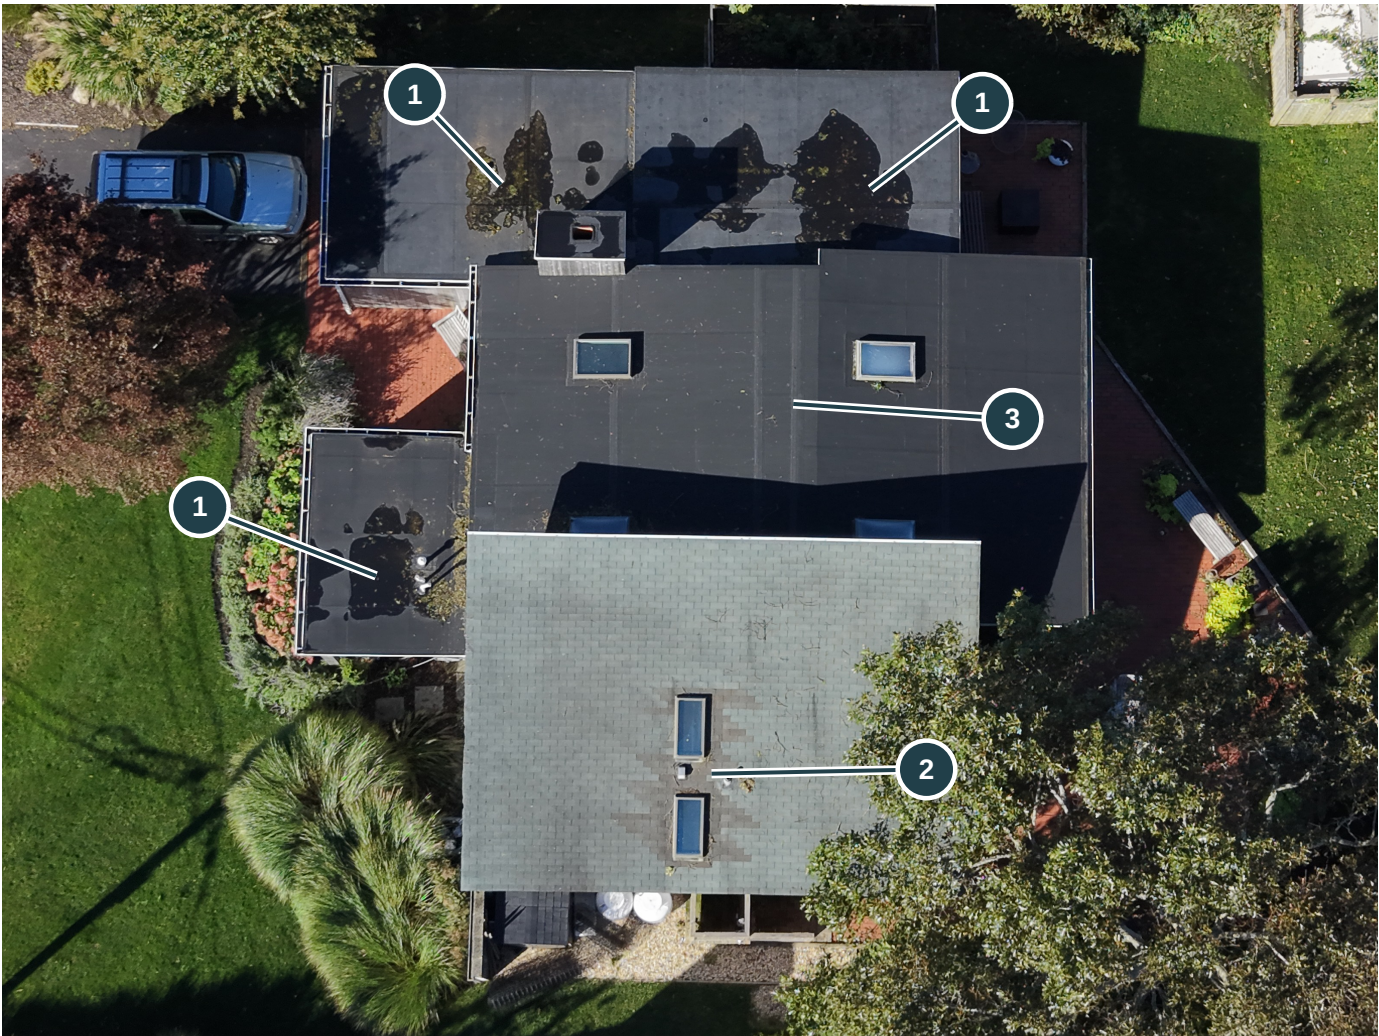
Overview from photo 0086. Marker 1 appears at three locations.

**01**  
**Apparent surface water**

Three visible areas  
Details on page 2

**02**  
**Skylight surroundings**

Visible color variation  
Details on page 2

**03**  
**Straight roof band**

Visible tonal change  
Details on page 3

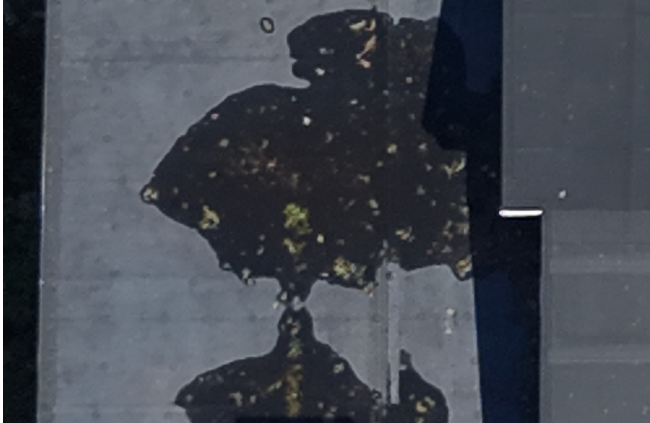
## 1 Apparent surface water

Detail from photo 0085

**Visible:** A dark, bounded area contains green and brown material.

**Unverified:** The image does not establish water depth, duration or drainage performance.

**Review:** Confirm conditions after a drying interval; check roof covering and outlets on site.

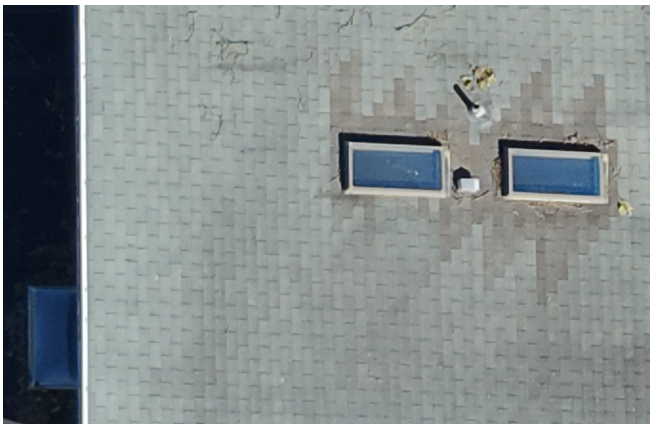
## 2 Skylight surroundings

Detail from photo 0085

**Visible:** Warmer-colored shingle courses surround two skylights and nearby roof penetrations.

**Unverified:** Color variation alone does not establish a leak or failed flashing.

**Review:** Check flashing, roof penetrations and relevant interior areas on site.

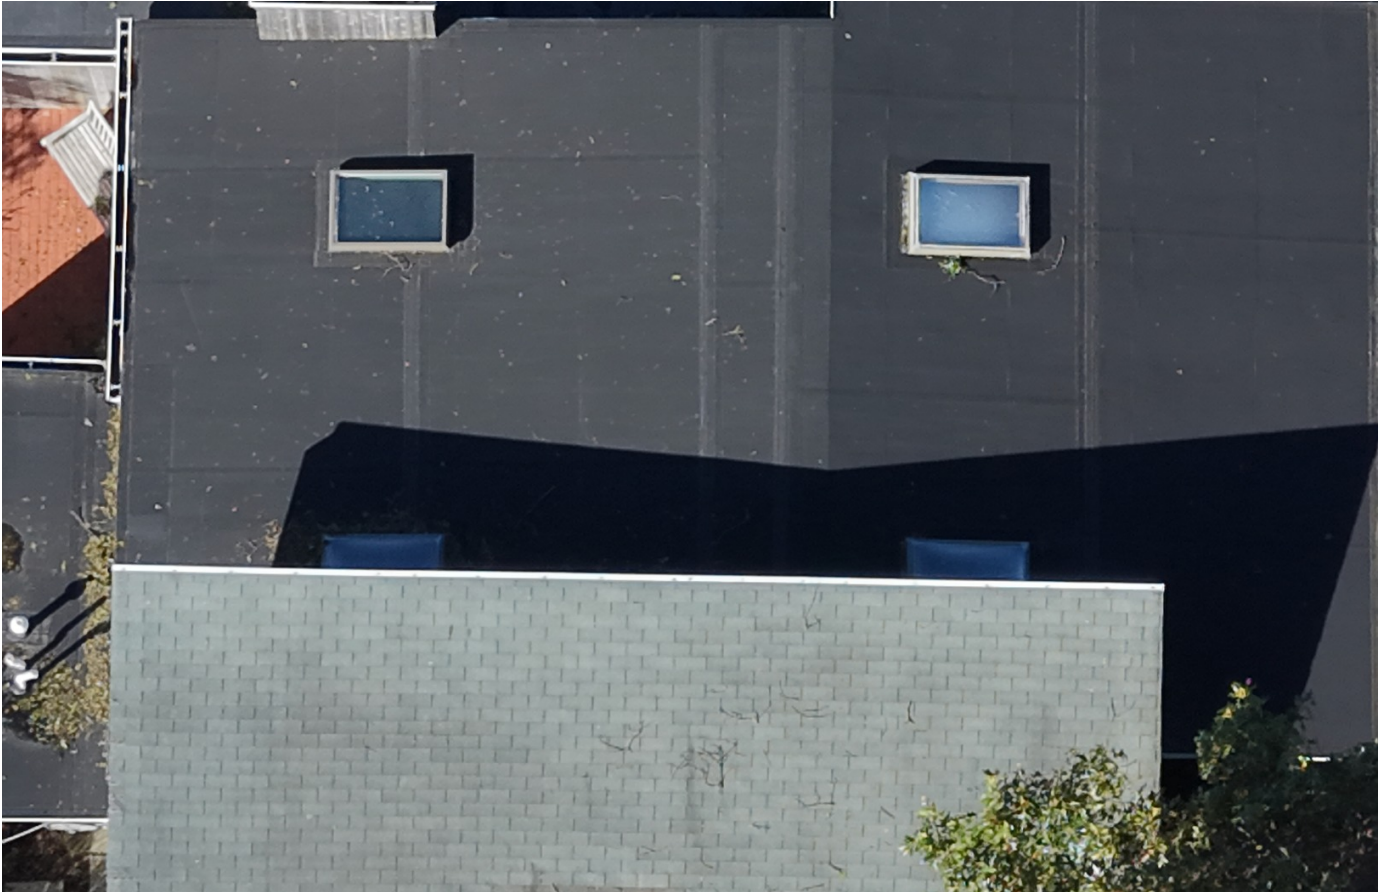
### 3 Straight roof band

A straight tonal band follows the geometry of the central roof area.

Detail from photo 0086. The tonal band is visible near the center.

**Visible:** No opening or missing material is evident in this view. The band may reflect a normal lap, coating or material change. A close on-site review is needed to identify the roof system and check the edges.
